# CORE-VISION REPORT

*Comprehensive Optimization & Reliability Evaluation for  
Vision Systems*

**Customer Name**  
Plant 5, Indianapolis

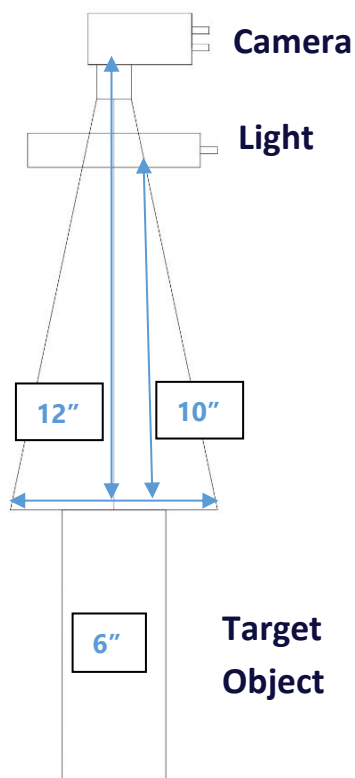
- This system is compliant with its defined scope of functionality.
- This system is running firmware revision level 6.01.01.
- This system has a **DISCONTINUED** product that is **UNAVAILABLE** for order as a replacement.
- This system has a redundant cell, so this system had been deemed as non-critical to operations.

| Risk | Identification of Risks | Recommended Corrective Actions |
|---|--|---|
| 1 | Fill Cell 001, Camera 1 is a discontinued product without an available direct replacement. | <b>1A:</b> We recommend that you have an upgrade plan in place. |

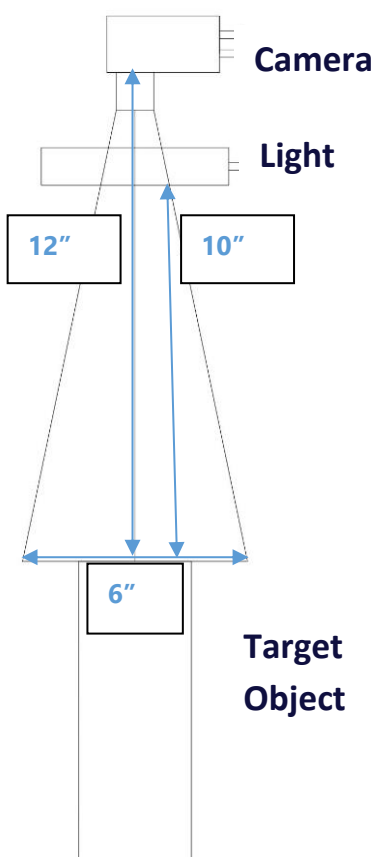
- This system is **NOT** compliant with its defined scope of functionality.
  - Find Circle tool is finding incorrect edges, causing the Find Edge tool to fail good parts.
- This system is running firmware revision level 6.01.01.
- This system is a current system that is available for order as a replacement.
- This system has a redundant cell, so this system had been deemed as non-critical to operations.

| Risk | Identification of Risks | Recommended Corrective Actions |
|---|--|---|
| 2 | Fill Cell 001, Camera 2 is out of compliance. <ul style="list-style-type: none"> <li>• It appears the stability of the product during presentation to the vision system has loosened.</li> <li>• The fixture tool is not reliably finding the correct circle to fixture on.</li> <li>• This causes the region of interest of the Edge Detection tool to be out of position.</li> <li>• Due to the incorrect location of the ROI, the Edge Detection tool is erroring out.</li> <li>• The result of this is the rejection of good parts.</li> <li>• This is raising the following costs: <ul style="list-style-type: none"> <li>○ Material</li> <li>○ Production rate</li> <li>○ Labor</li> </ul> </li> </ul> | <b>2A:</b> It is our recommendation that the camera has the fixturing programming updated with a more appropriate technique, that would be able to handle the wear of the conveyance equipment.<br><br><b>2B:</b> You could replace the conveyance system to bring the location of the part within original scope. This would likely be the more expensive option. You will also likely need to do this, eventually to all the cells. |

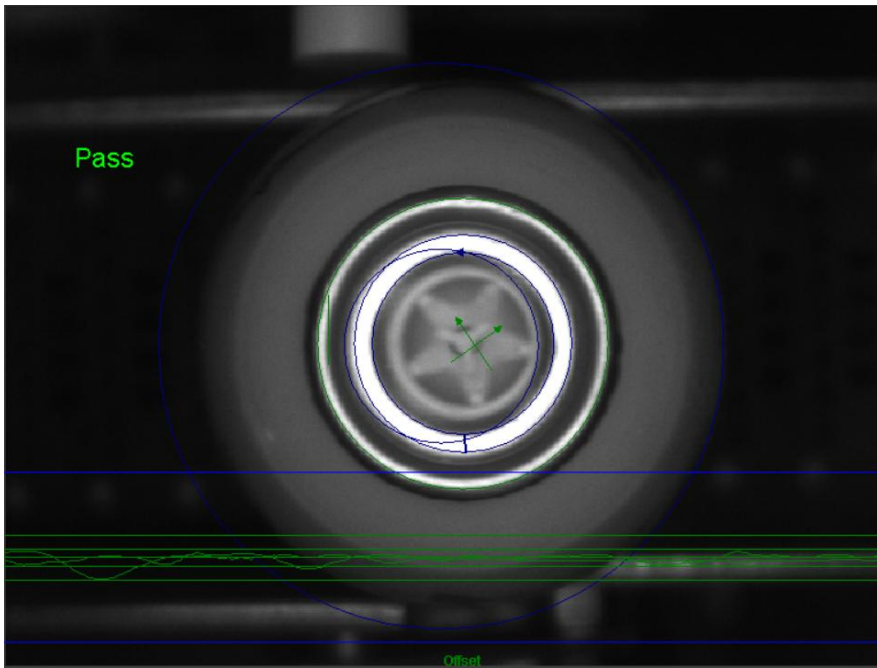
Here you see the perimeter of the crimp is found.

You can see the tools are all functioning properly.

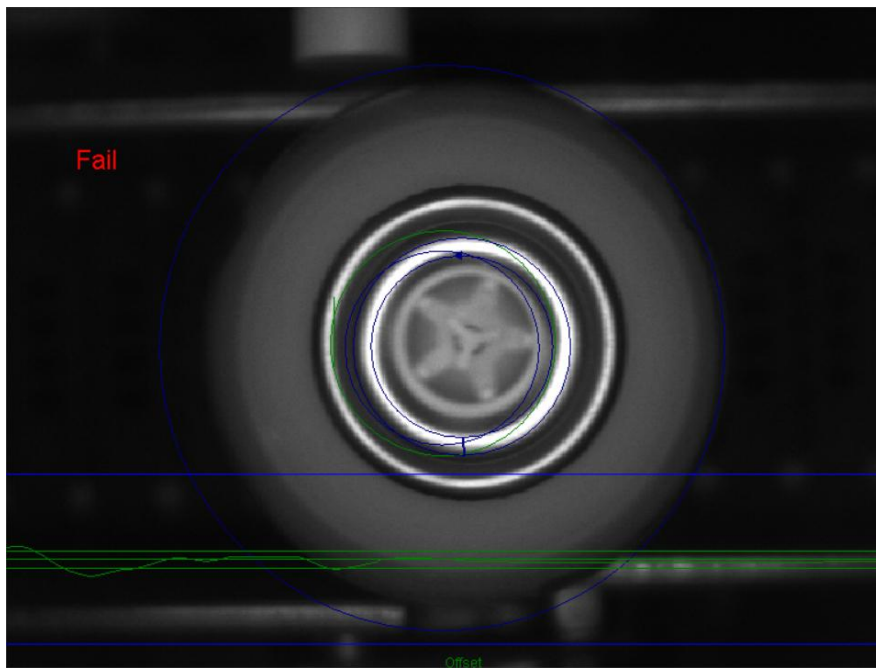
Here you see the perimeter of the crimp was not found properly

The Edge Detection tool is errored out due to the incorrect positioning of its ROI.
