# CORE-VISION REPORT

*Comprehensive Optimization & Reliability Evaluation for  
Vision Systems*

**Customer Name**  
Plant 5, Indianapolis

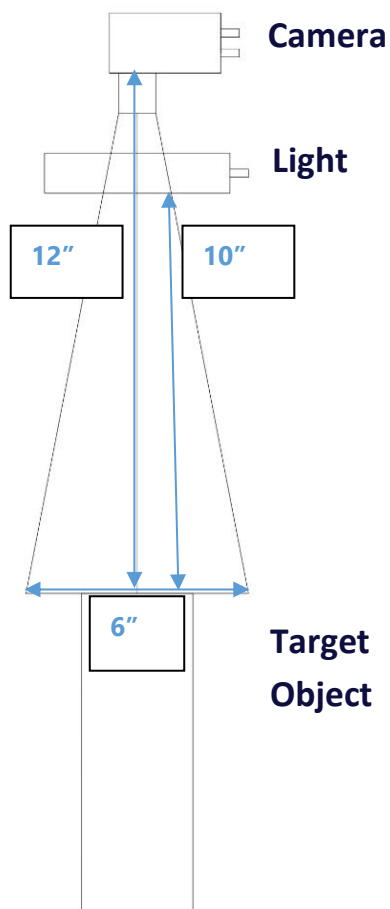
### PHYSICAL SETUP

- Camera is mounted directly above the part, with a working distance of 12", looking directly through the ring light.
- Distance of the light from the camera is 10.0" directly above the camera, on axis with the camera and part.
- The Field of View is 6.0"
